**Pavement Performance Evaluation  
Burlington-Northern & Santa Fe Railroad  
Intermodal Facility  
Denver, Colorado**

Job Number 02-0182

November 18, 2002

**Performance Evaluation  
BNSF Intermodal Facility  
Denver, Colorado**

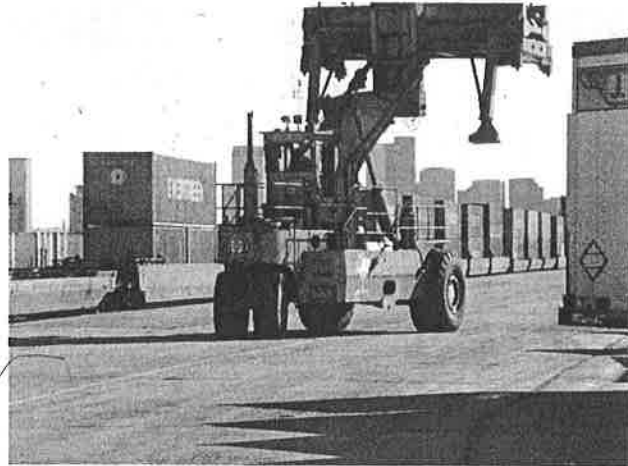
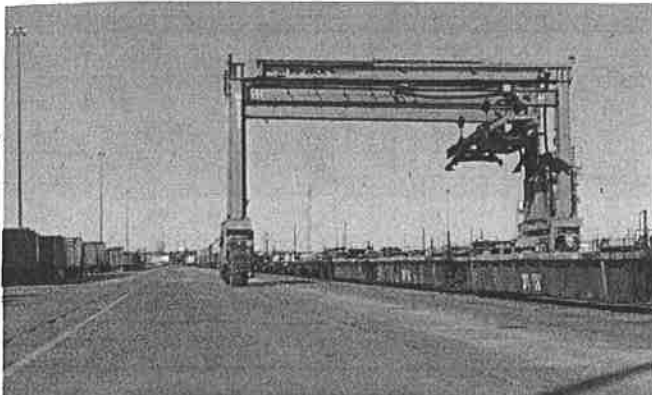
A transfer loader is pictured at right.

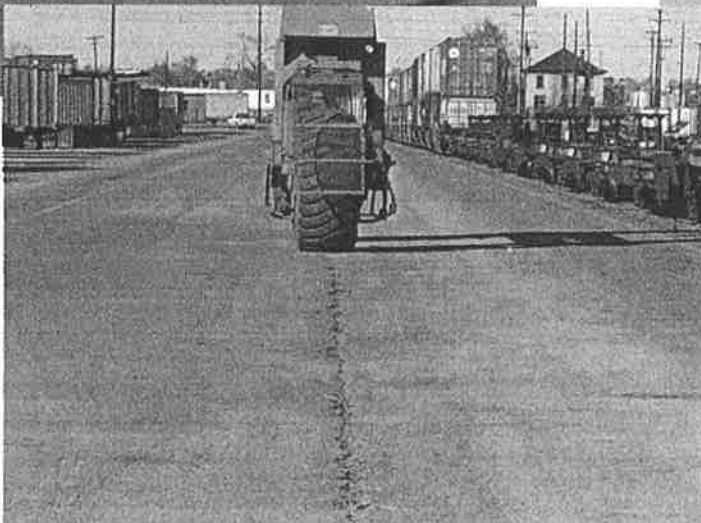
The large loader transfer device shown at left and below exerts high tire stress and also runs directly on an original paving joint as shown.

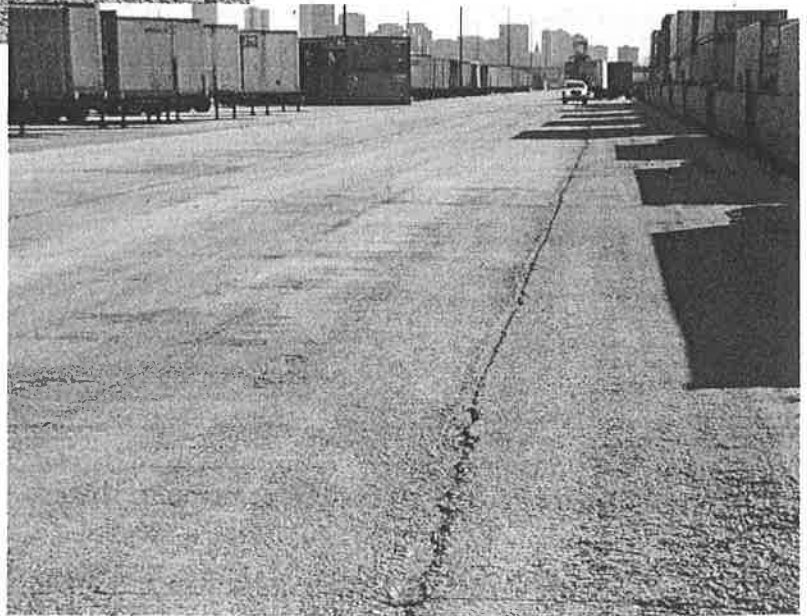
One area of concern shortly after completion of construction was the condition of the longitudinal joints. These cold joints showed some raveling and segregation at the top corners after construction and look very similar now, after almost 17 years. Maintenance on the pavement has been very minimal and the surface is still providing excellent service. These photos show the current joint condition.

The smaller transverse cracks seen are due to initial shrinkage after placement.
